Fwd: TDOT - Bridge Fed.ID. # 05S24980003 (Wildwood Rd. over Branch) in Blount County Requires Weight Limit Posting.

BRIDGE INSPECTION REPORT (CULVERTS)

WILDWOOD ROAD OVER BRANCH
ROAD NAME STREAM NAME STRUCTURE NAME (IF NAMED)

INSPECTION TEAM'S SUMMARY

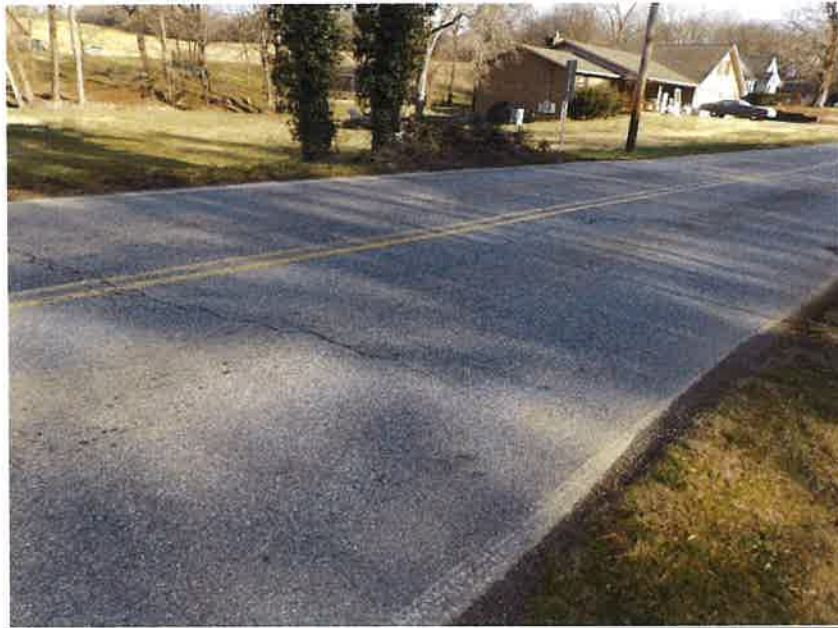
VIEW ACROSS DECK (NOTE: MINOR RAVELLING)

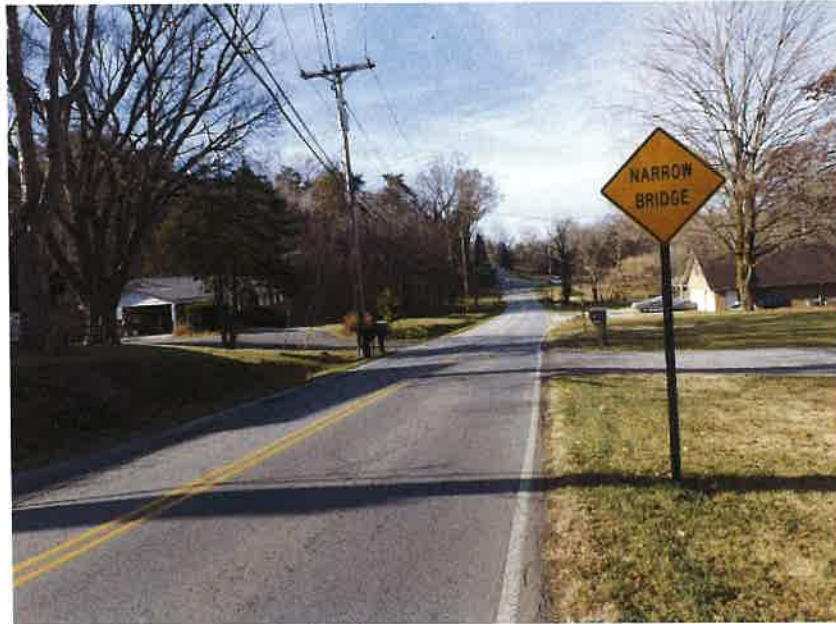
SIGN - NARROW BRIDGE APPROACH 2

INSTALL "NARROW BRIDGE" WARNING SIGNS AT APPROACH 1

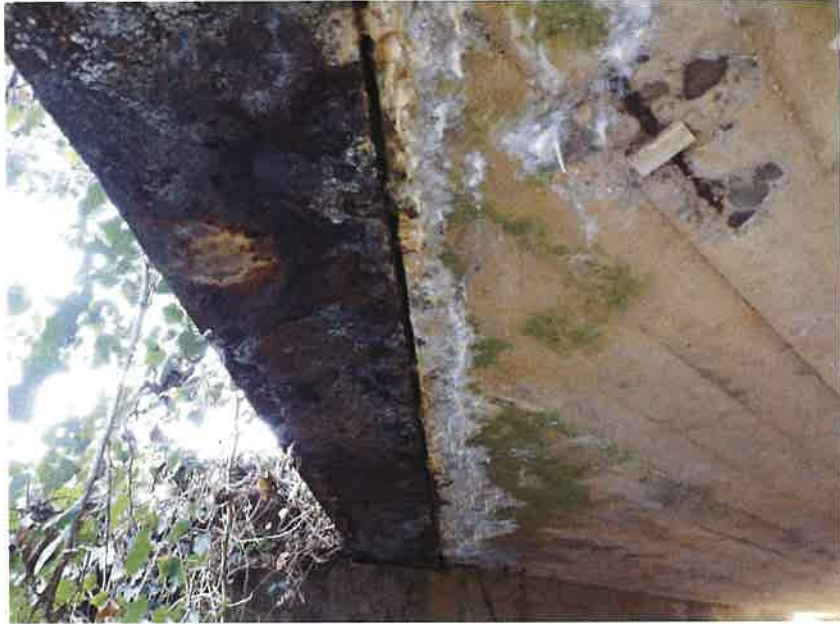
CRACK W/LEACHING TOP BARREL 2 OUTLET

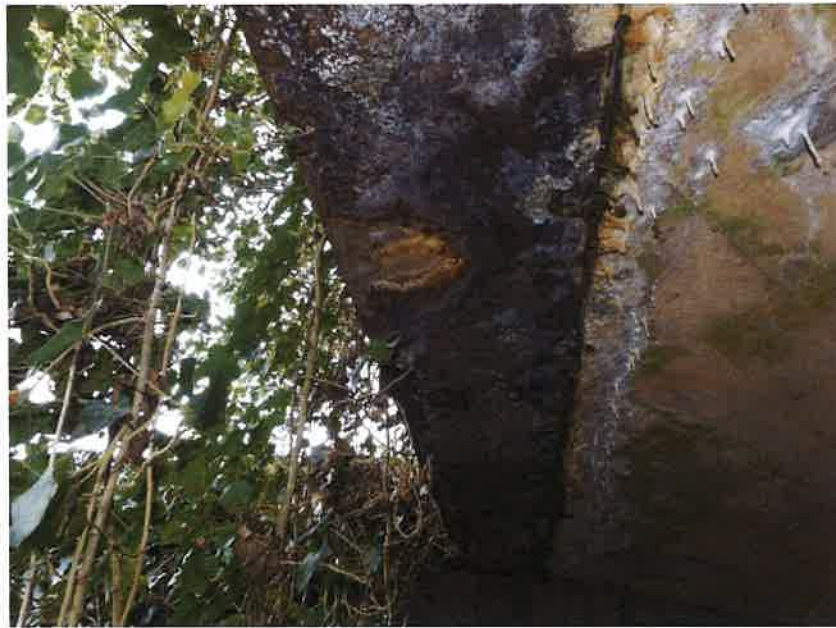
HEAVY CORROSION BEAM OUTLET

BOTTOM DECK	F	(1) SPALLING UP TO 1" DP. W/EXPOSED REBAR
STEEL BEAMS	P	HEAVY CORROSION & FLAKING, NO LOSS OF SECTION

BOTTOM DECK	F	(1) SPALLS 2' X 1' UP TO 1" DP. W/EXPOSED REBAR
STEEL BEAMS	P	HEAVY CORROSION & FLAKING; LOSS OF SECTION - UP TO 50% OF BOTTOM FLANGE

CLEAN & PAINT STEEL CHANNEL BEAMS UNDER CURB LINES

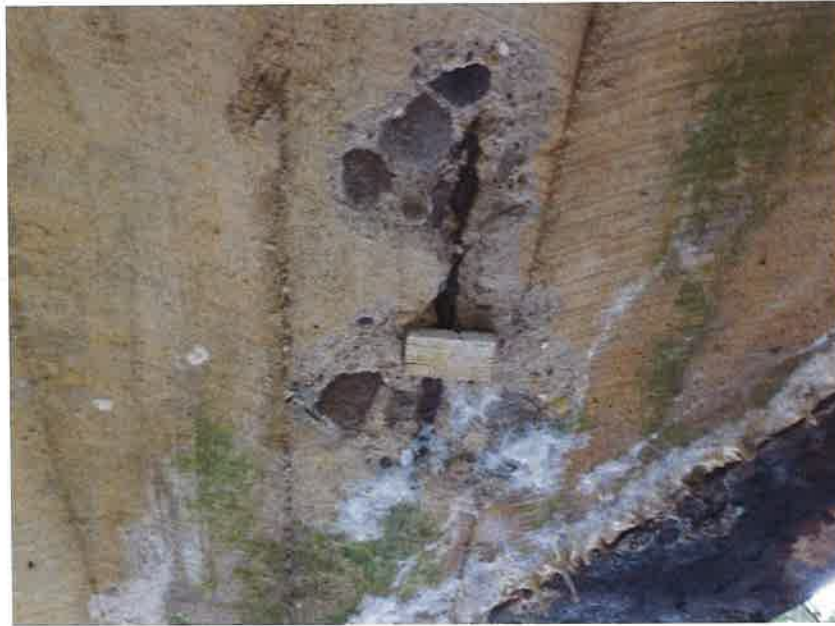
SPALL EXPOSED REBAR TOP BARREL 2 OUTLET

No.	RECOMMENDATIONS	REPAIR DATE	REPAIRED BY
1.	PATCH BOTTOM OF DECK SPAN 1 & 2		
2.	PROTECT FILL BEHIND RIGHT WING ABUT 1 & 2 FROM SCOUR		
3.	REPAIR LEFT WINGWALL AT ABUTMENT NO. 2		
4.	REPAIR BREASTWALL AT ABUTMENT NO. 2		
5.	REMOVE DRIFT AT INLET

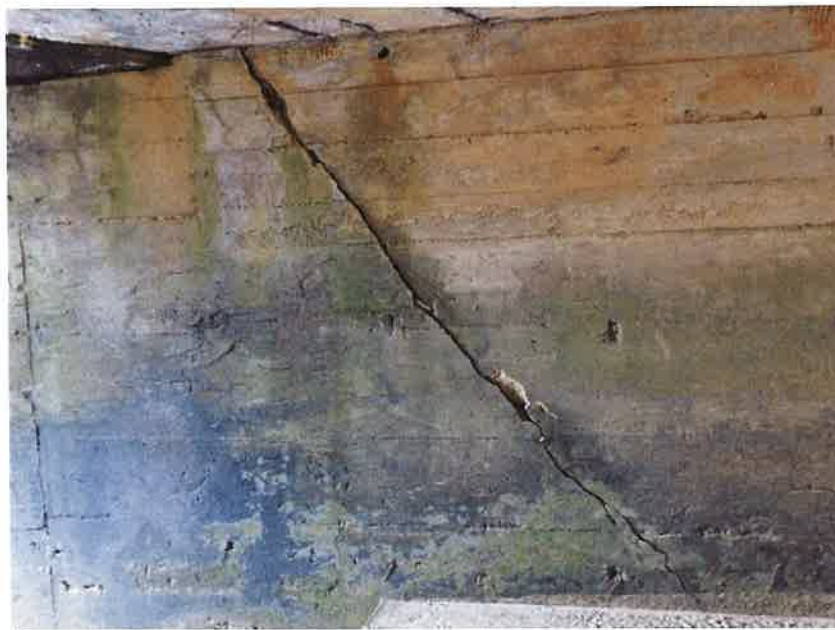
CRACK UP TO 1/2" OPEN BREASTWALL ABUTMENT 2

The abutment and pier walls of the bridge are in fair condition with scale and honeycomb. The abutment breastwall on the number 2 side is rated poor due to being cracked open up to ½” at the left end. This section at the upstream end of Abutment 2 is no longer flush with the remaining section of the abutment wall – however, this condition has existed for some time and doesn’t appear to have changed any since the previous inspection of 2016. The steel channel beams are in fair condition with heavy corrosion, and the bottom flange on one of them is slightly kinked. Bottom deck has 1” deep spalling with rebar exposed.

BREASTWALL	P	(1) 1/2" OPEN CRACK - BREASTWALL SECTIONS NO LONGER FLUSH W/EACH OTHER
WINGS	F	(2) DOWNSTREAM WING: AREA HONEYCOMBED COMPLETELY THROUGH
FOOTING	F	(3) 1/8" OPEN CRACKS

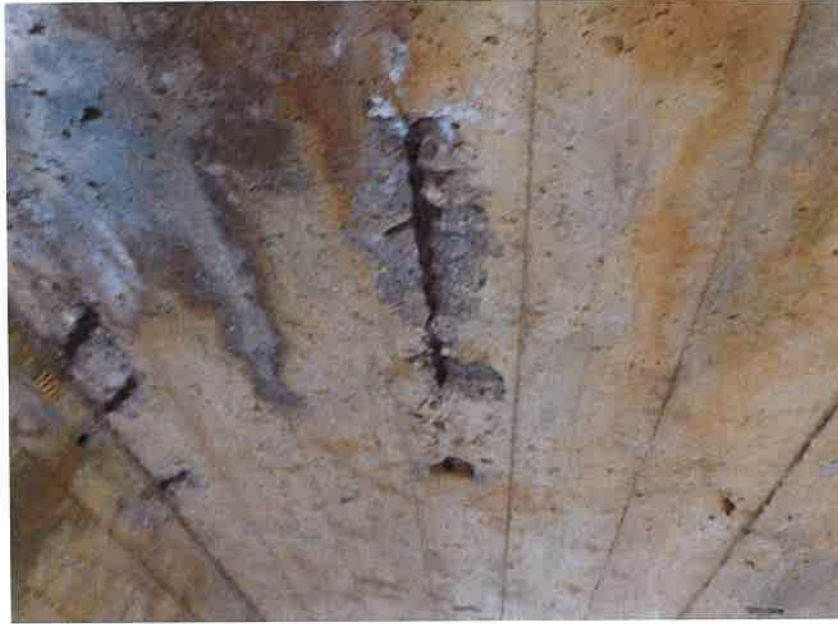
SPALLS EXPOSED REBAR TOP BARREL 2 NEAR OUTLET

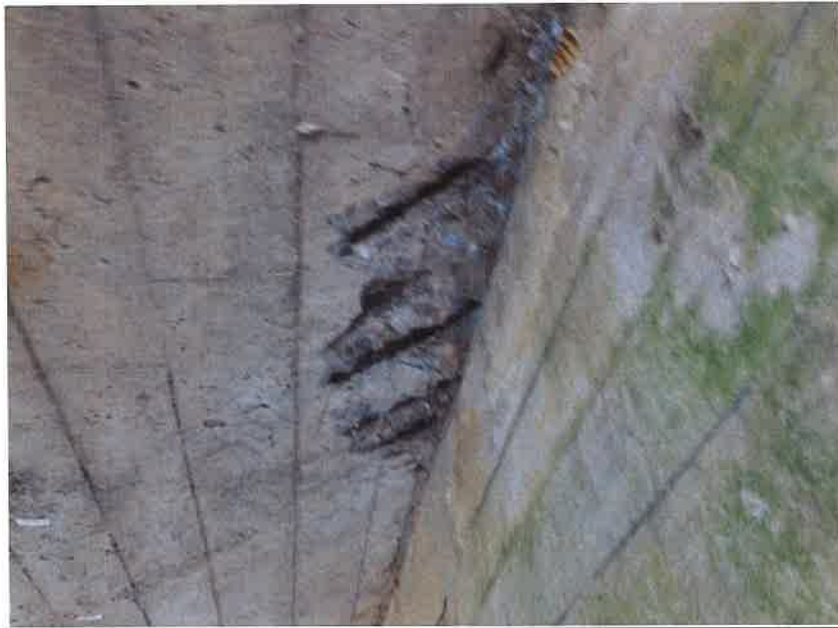
SPALL EXPOSED REBAR TOP BARREL 2 NEAR OUTLET

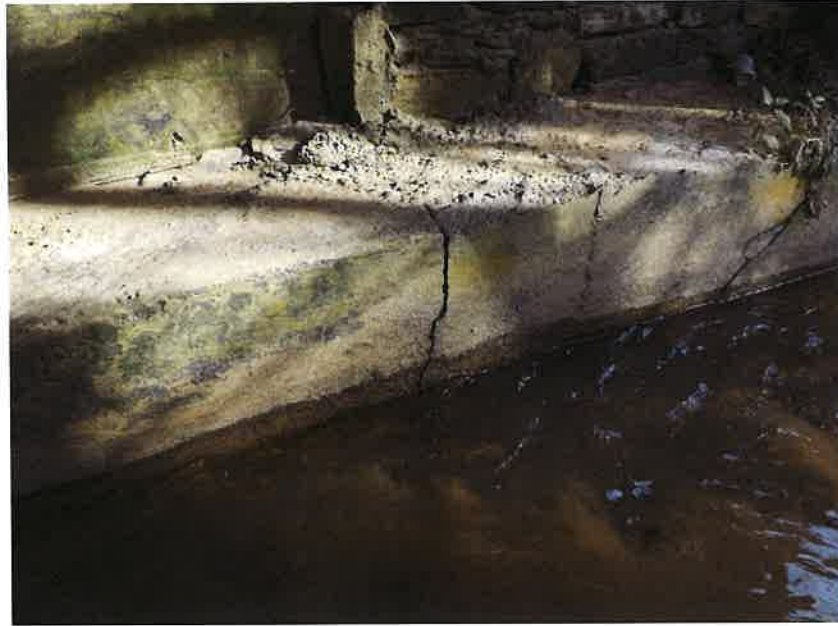
CRACK SILL ABUTMENT 2 NEAR INLET

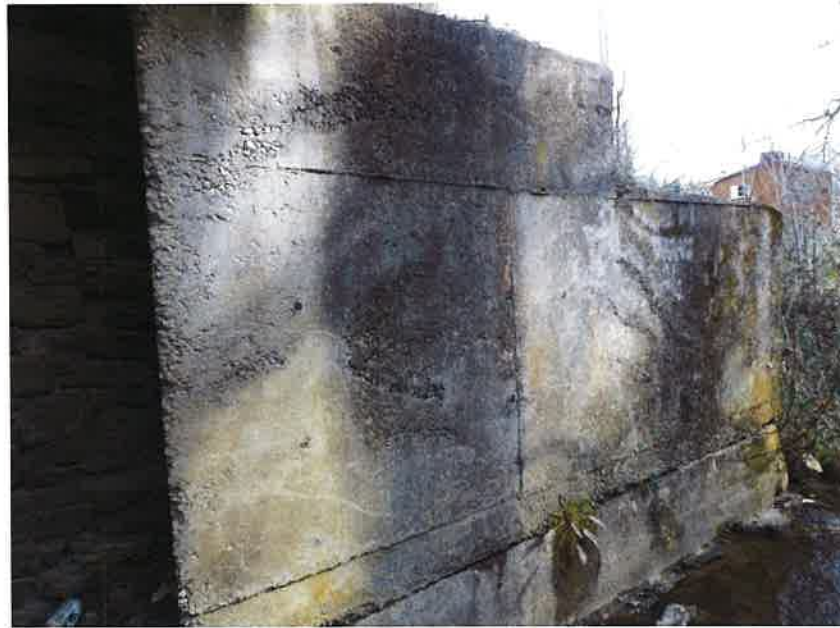
HONEYCOMB WING 2 RIGHT

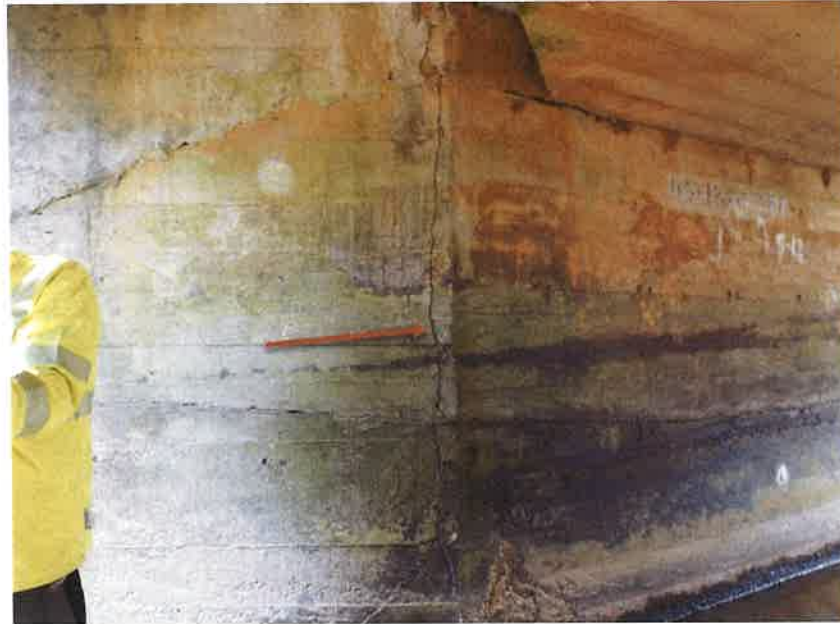
CRACK UP TO 1/8" OPEN WING 1 RIGHT

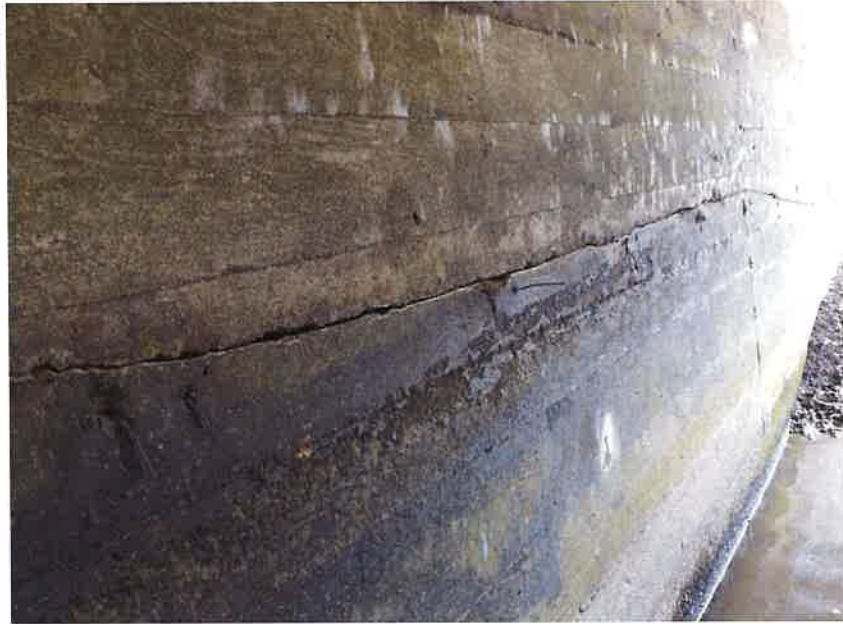
CRACK UP TO 1/8" OPEN BREASTWALL ABUTMENT 1

BREASTWALL	F	(1) AREAS OF SCALE/HONEYCOMB UP TO 2" DP. (3) CRACK UP TO 1/8" OPEN ACROSS ENTIRE WIDTH
WINGS	F	(2) UPSTREAM WING: CRACKING UP TO 1/8" OPEN

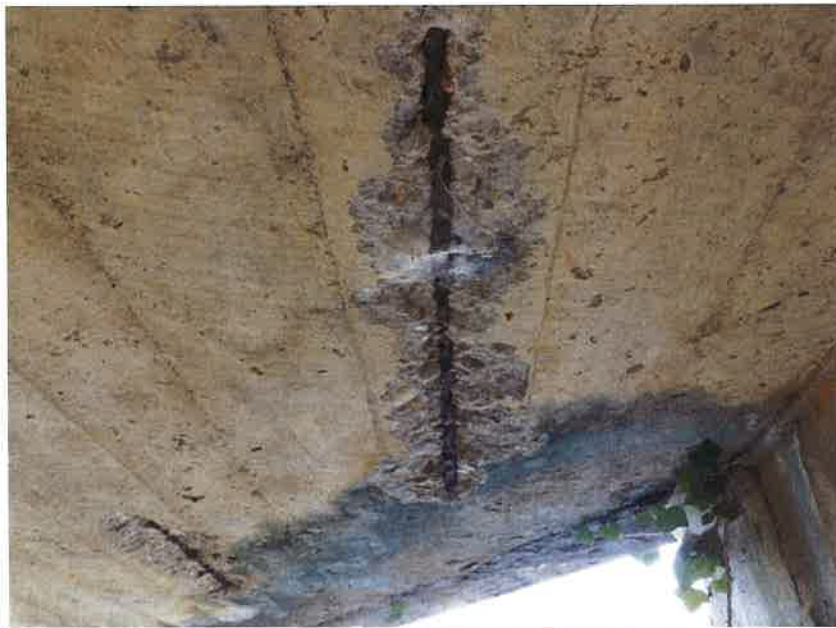
SPALLS EXPOSED REBAR TOP BARREL 1 NEAR OUTLET

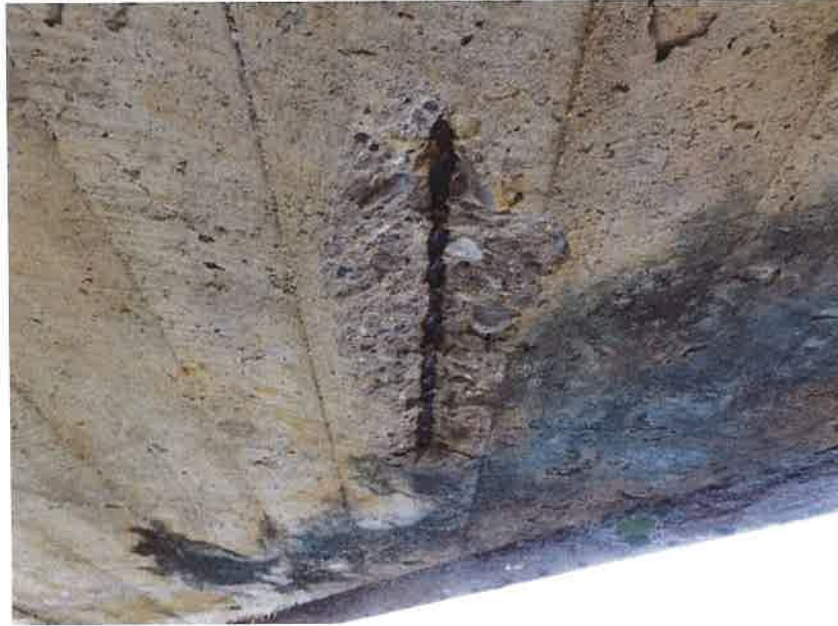
SPALL EXPOSED REBAR TOP BARREL 1 NEAR OUTLET

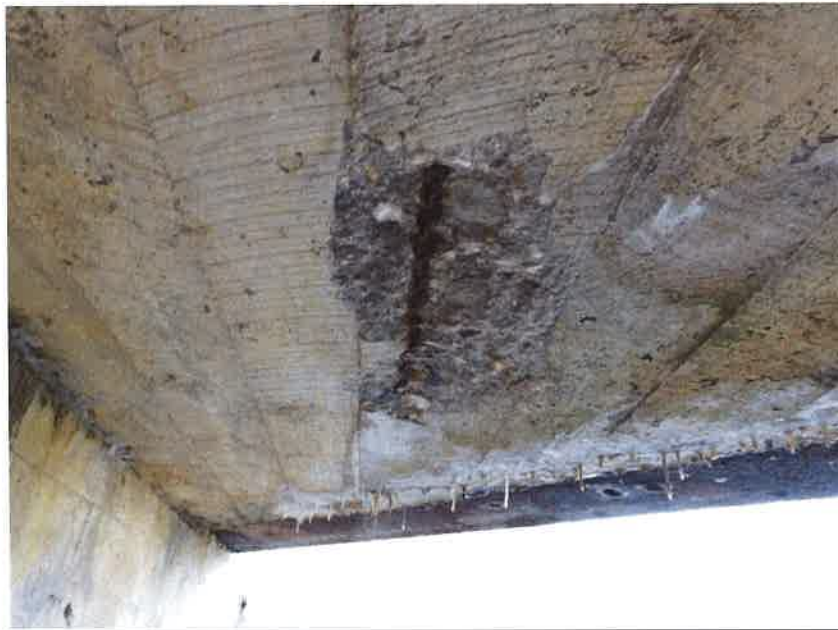
SPALL EXPOSED REBAR TOP BARREL 1 NEAR OUTLET

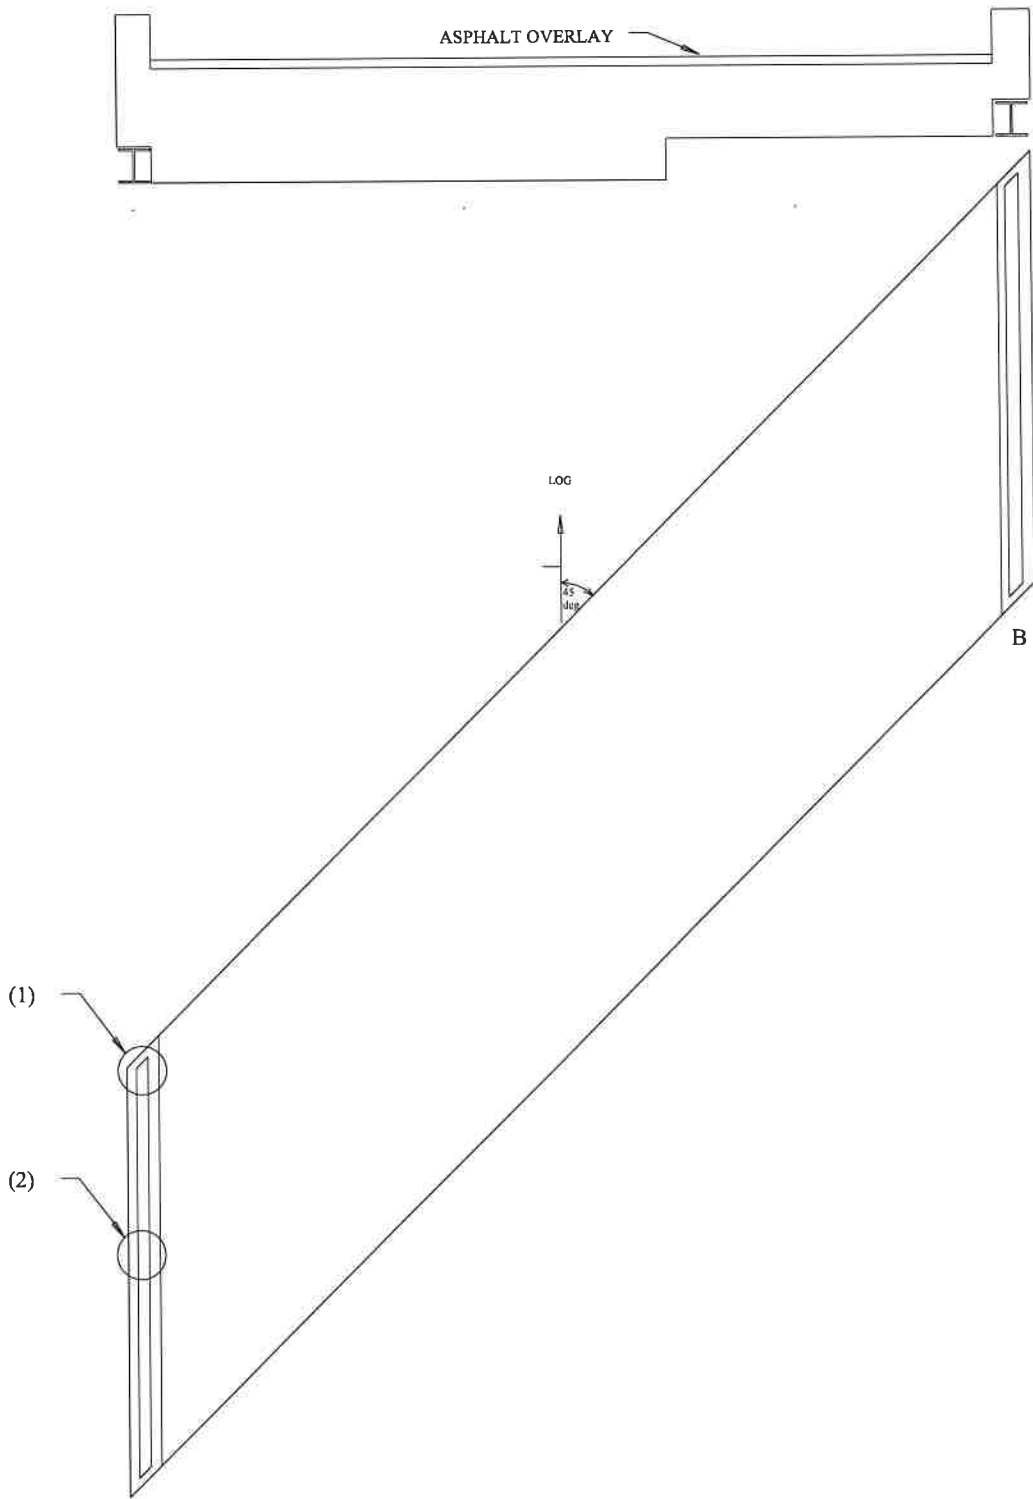
SPAN 1 & 2

WEARING SURFACE	G	
BRIDGE RAIL	P	(2) DOWNSTREAM RAIL BROKEN OVER PIER
CURBS	P	(1) DOWNSTREAM CURB BROKEN NEAR END OF BRIDGE
		OTHERWISE, AREAS OF SCALE

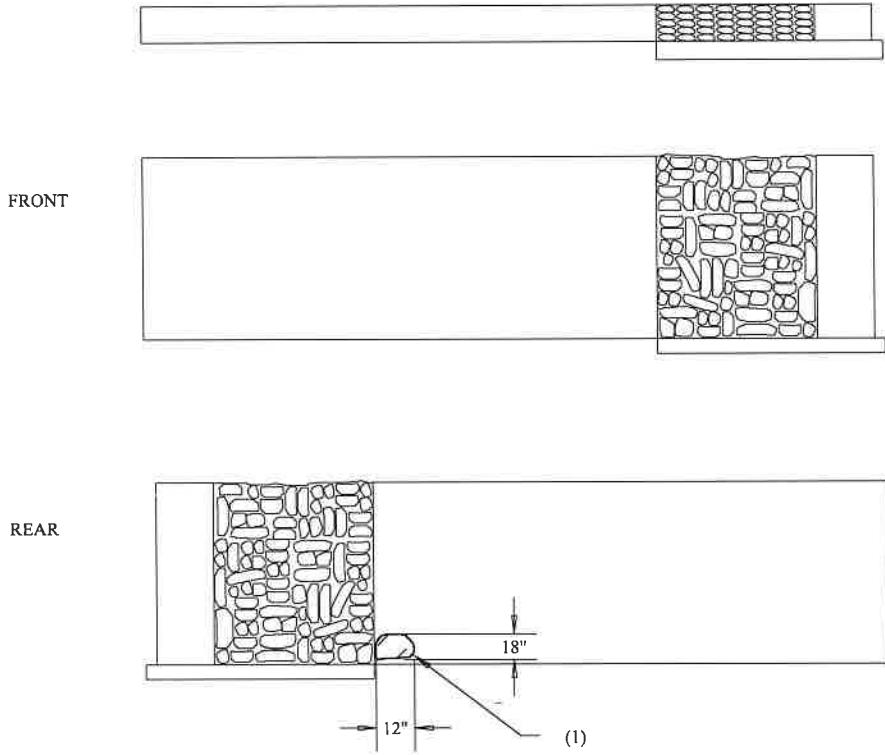
PIER NO. 1

WALL	F	(1) AREA OF SCALE/HONEYCOMB UP TO 2" DP. SOME LOSS OF MORTAR @ MASONRY SECTION
FOOTING	F	FOOTING FAIRLY SOUND, CRUDELY FORMED
