BRIDGE MAINTENANCE RECOMMENDATIONS

**Clover Hill Road
Over Baker Creek
Br. Loc. No. 05-1267-01.75
I.D. No. 05012670001**

BRIDGE INSPECTION REPORT (CULVERTS)

INSPECTION TEAM'S SUMMARY

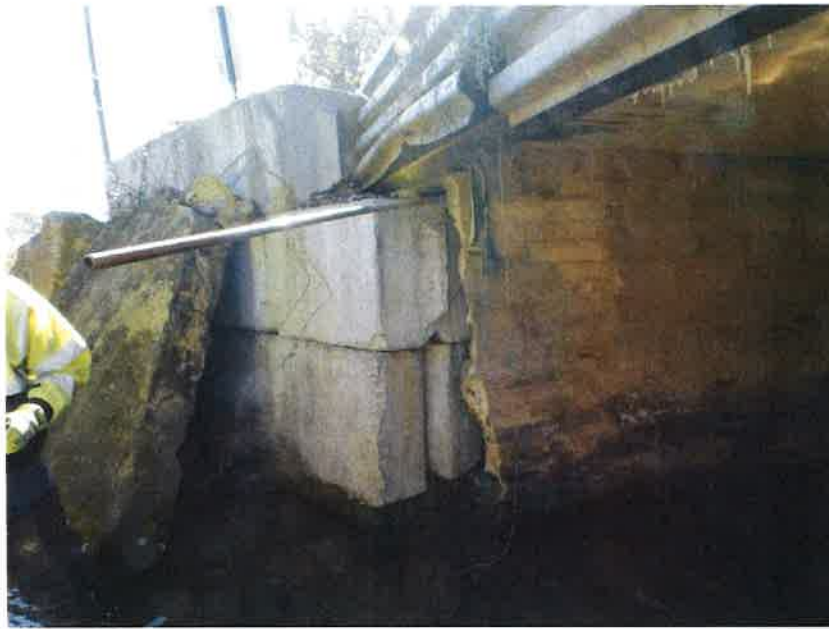
VOID BEHIND WING 2 LEFT

COMMENTS: * BEHIND ABUTMENT 2 LEFT AND WING 2 LEFT.
 *** VOIDS STILL EXIST BEHIND IT.

No.	RECOMMENDATIONS	REPAIR DATE	REPAIRED BY
1.	REPAIR WINGWALLS		
2.	REPAIR EMBANKMENT EROSION ON LEFT SIDE OF APPROACH NO. 2		
3.	REPAIR VOIDS/SPALLS IN BARREL WALLS		
4.	STABILIZE RIGHT SIDE HEADWALL		
5.	REPAIR UNDERMINING AT OUTLET END OF BARRELS AND WING

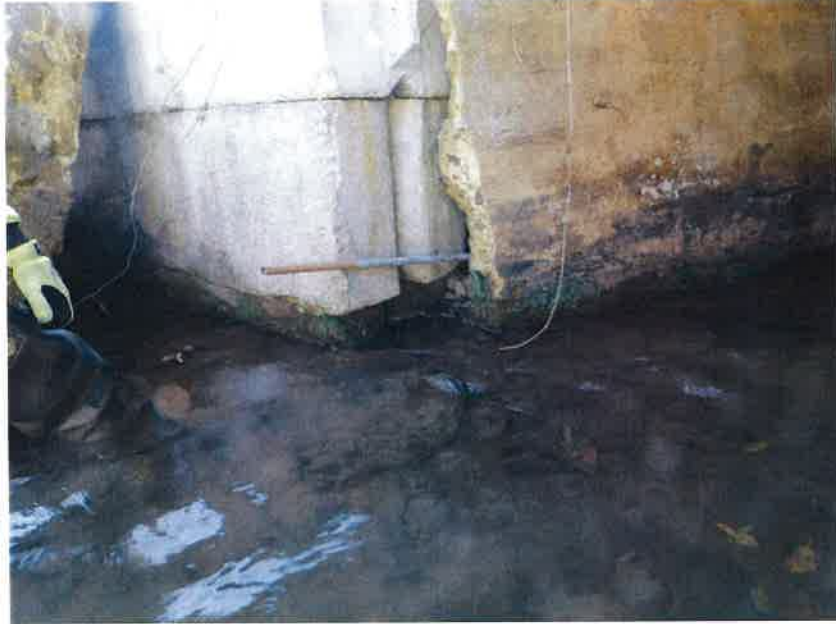
VOID BEHIND ABUTMENT 2 AND WING 2 RIGHT

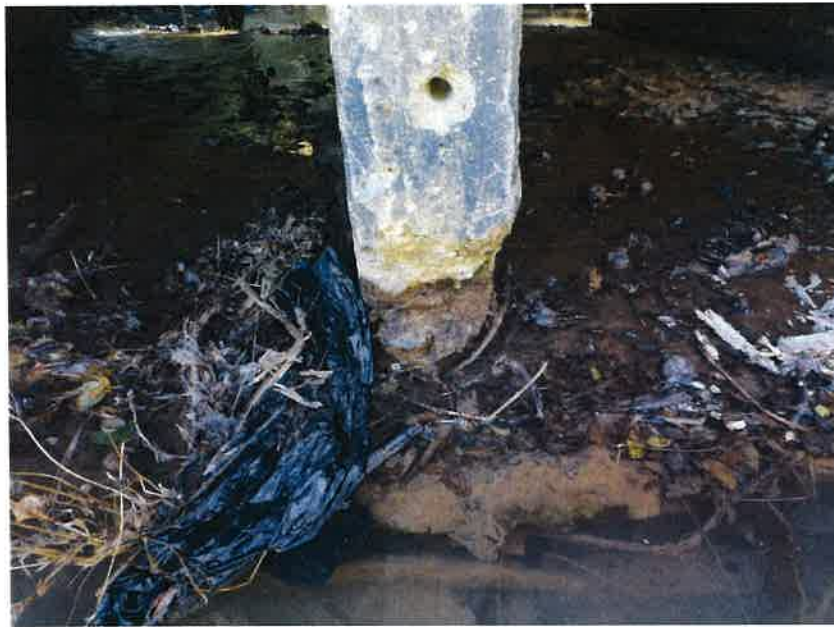
SCALE AT MIDWALL INLET WATERLINE

Barrel concrete is in poor condition with spalling and honeycombing deep enough to expose the fill behind the outside walls. The mid-wall has scale up to 6" deep at the waterline, both inlet and outlet sides. The wings are rated poor with wing 2 right being cracked and having a slight rotation toward the stream. Wing 1 right is completely undermined and is just hanging there. Wing 2 left was replaced with concrete interlocking blocks, but there are still unknown voids behind it. Headwalls are in poor condition with the right headwall having a 1/2" rotation away from the roadway. There is a steel I-beam placed on the outside of the headwall on the left side and with the rotation of the wing, there is less than an inch of bearing area left holding it up. It is unknown how far the I-beam extends along the roadway and onto the fill.

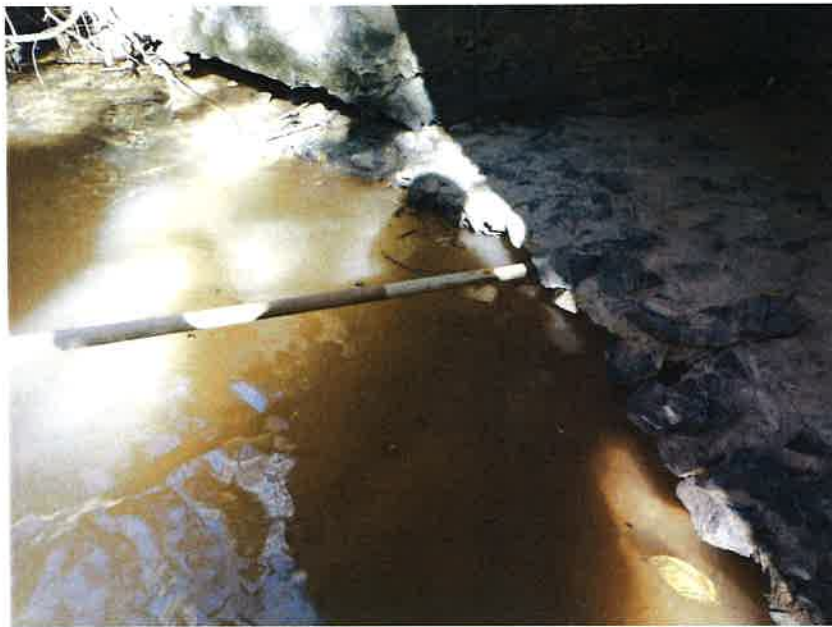
UNDERMINING AT BARREL 1 OUTLET

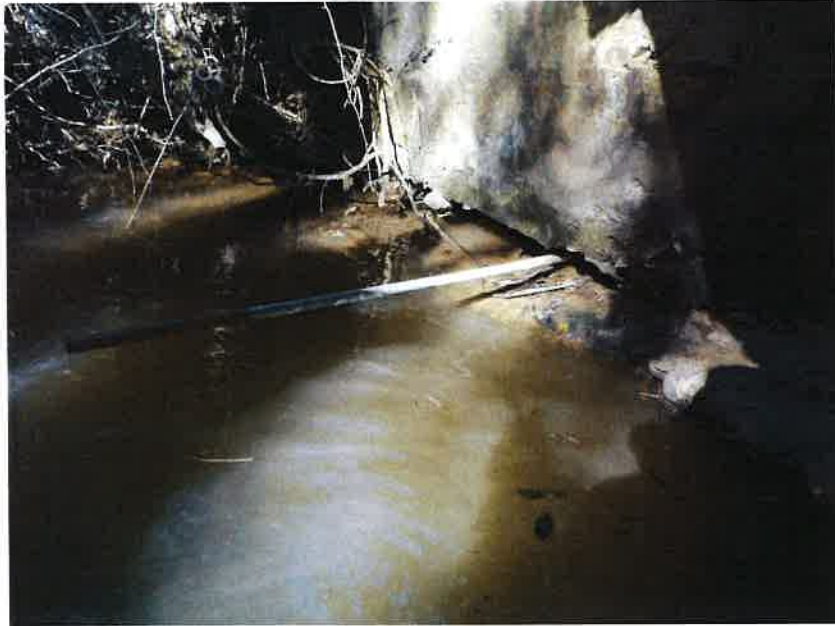
UNDERMINING AT WING 1 RIGHT OUTLET

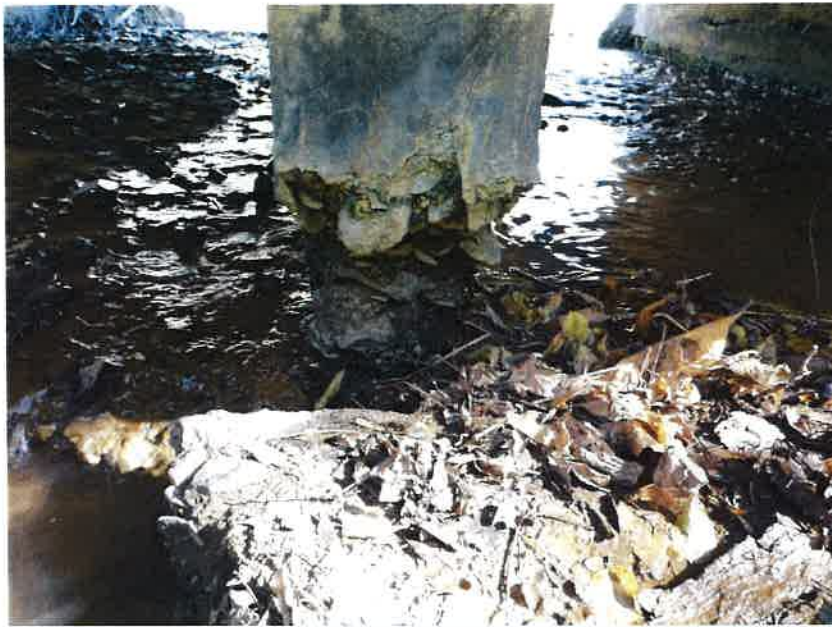
HEAVY SCALE MIDWALL AT OUTLET WATERLINE

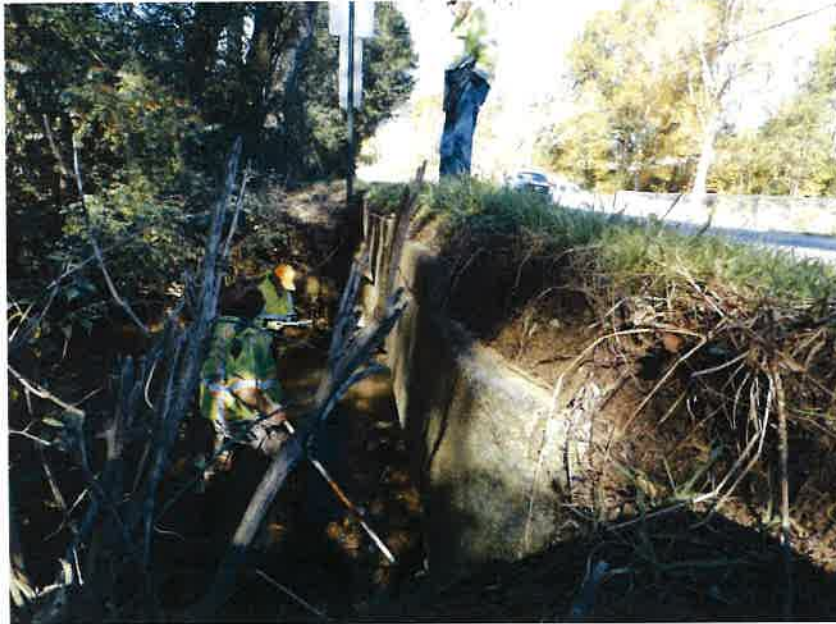
ROTATION OF RIGHT SIDE HEADWALL

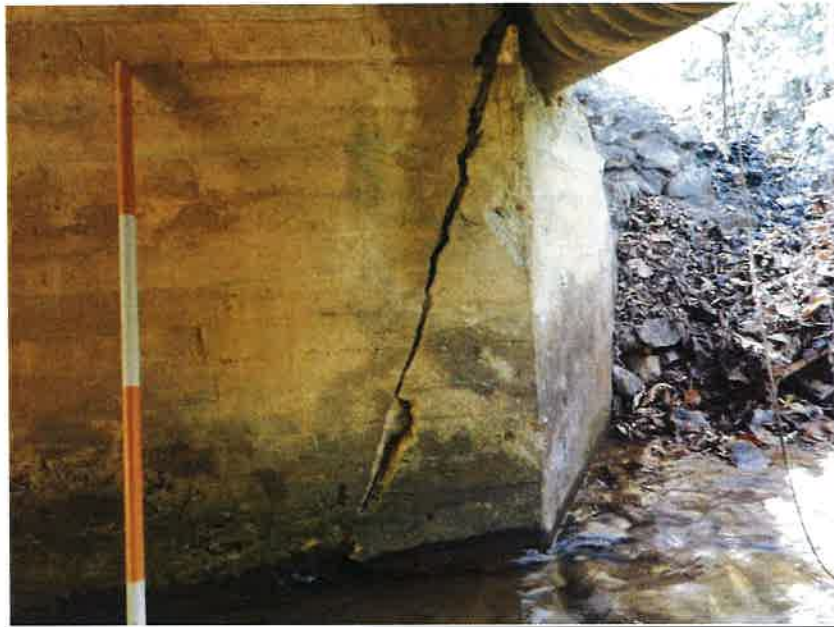
CRACK AND ROTATION OF WING 2 RIGHT

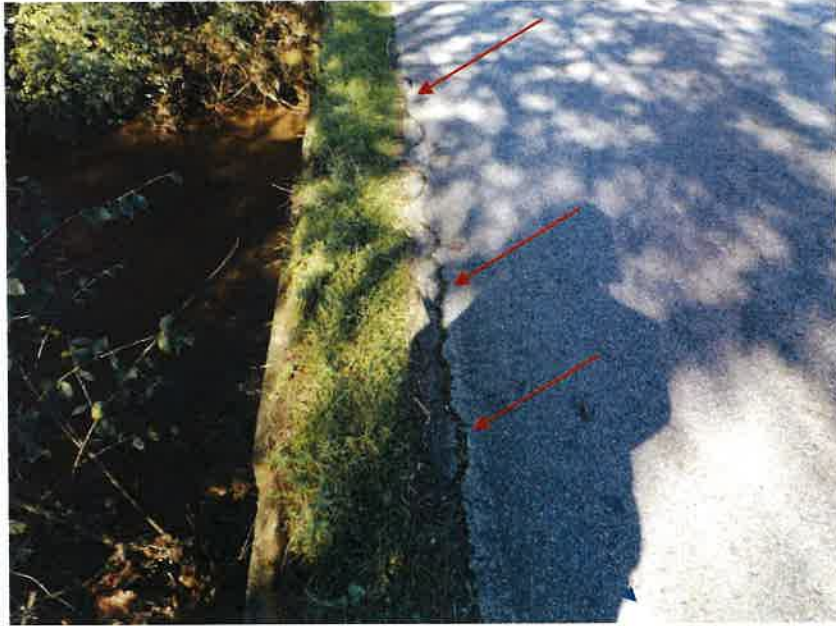
ROTATION OF RIGHT HEADWALL NOTE SEPARATION CRACK

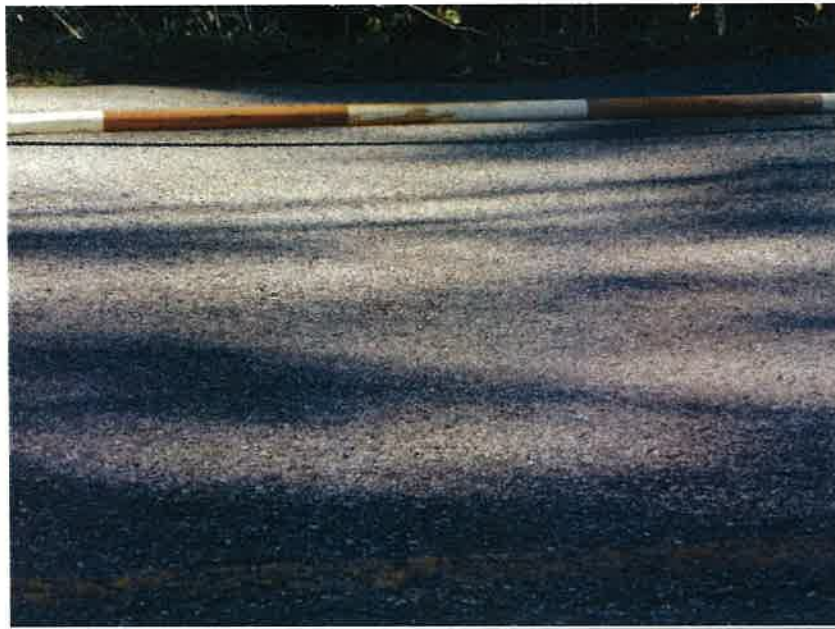
SLUMPING/SETTLEMENT AT APPROACH 1 RIGHT

The subject box culvert bridge was inspected on the above date and found to be in serious condition. Roadway alignment is good. Continuous asphalt overlay across the approaches and the top of the bridge is in good condition, however, there is slumping and settlement at approach 1 right and approach 2 left due to the voids and undermining. No traffic safety features exist. Paddleboard signs are in place for approaching traffic; however they are needed at all four corners. Weight posting signs for 6/11 TONS are present at both approaches.

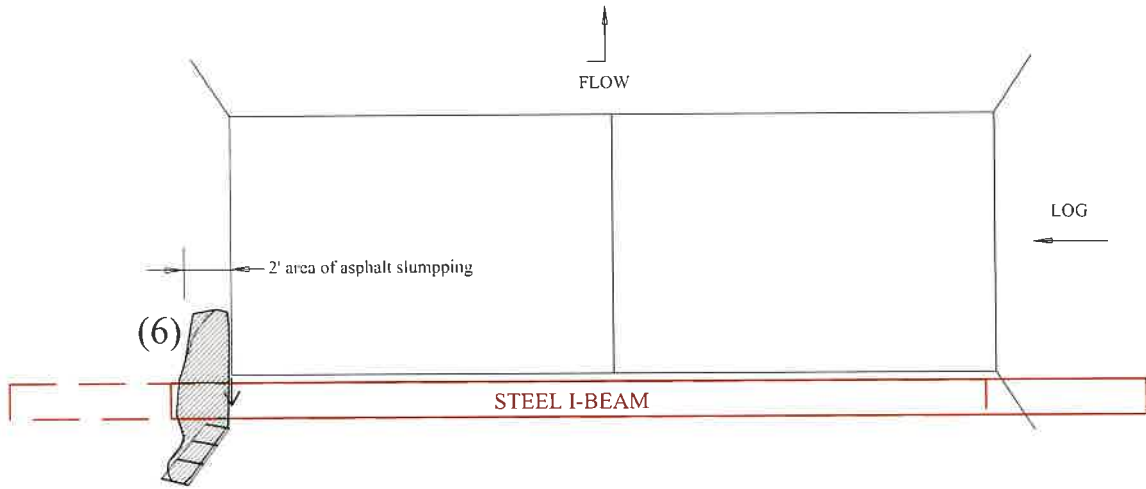
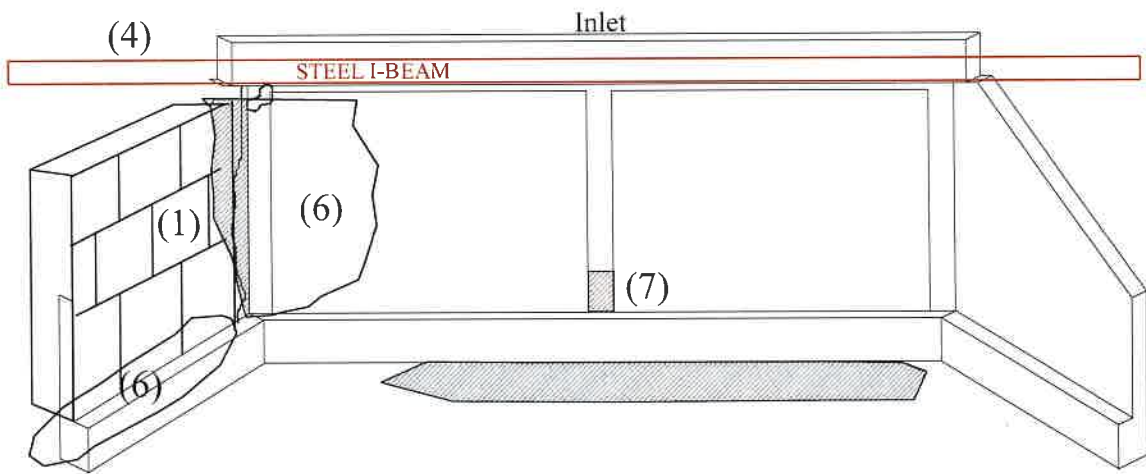
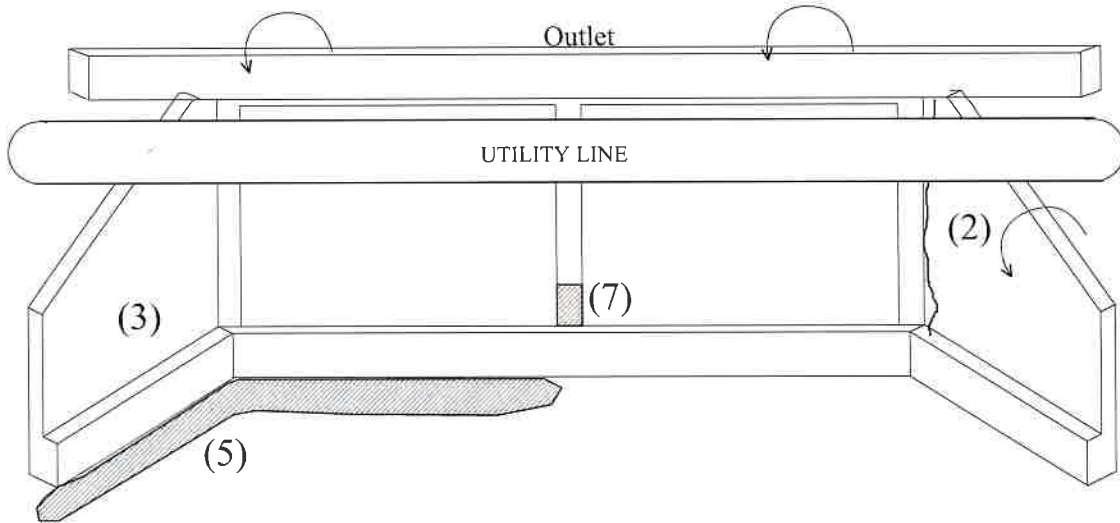
LOC. 05-1267-1.75

INLET HDWALL	F	(7)HEAVY SCALE OF MIDWALL AT WATERLINE
WINGS	P	(1)WING 2 LEFT REPLACED WITH CONCRETE INTERLOCKING BLOCKS, UNKNOWN VOIDS BEHIND THEM (4)A STEEL I-BEAM HAS BEEN PLACE ON THE INLET SIDE FOR SUPPORT OF FILL
OUTLET HDWALL	F	(7)HEAVY SCALE OF MIDWALL AT WATERLINE
WINGS	P	(2)WING 2 RIGHT HAS CRACKING AND MODERATE ROTATION (3)WING 1 LEFT IS COMPLETELY UNDERMINED AND IS HANGING IN MID-AIR
SCOUR	P	(5)SCOUR IS PRESENT AT BOTH INLET AND OUTLET WITH WING 1 RIGHT COMPLETEL
EMBANKMENT	P	(6)VOID BEHIND BARREL WALL AND WING 2 LEFT

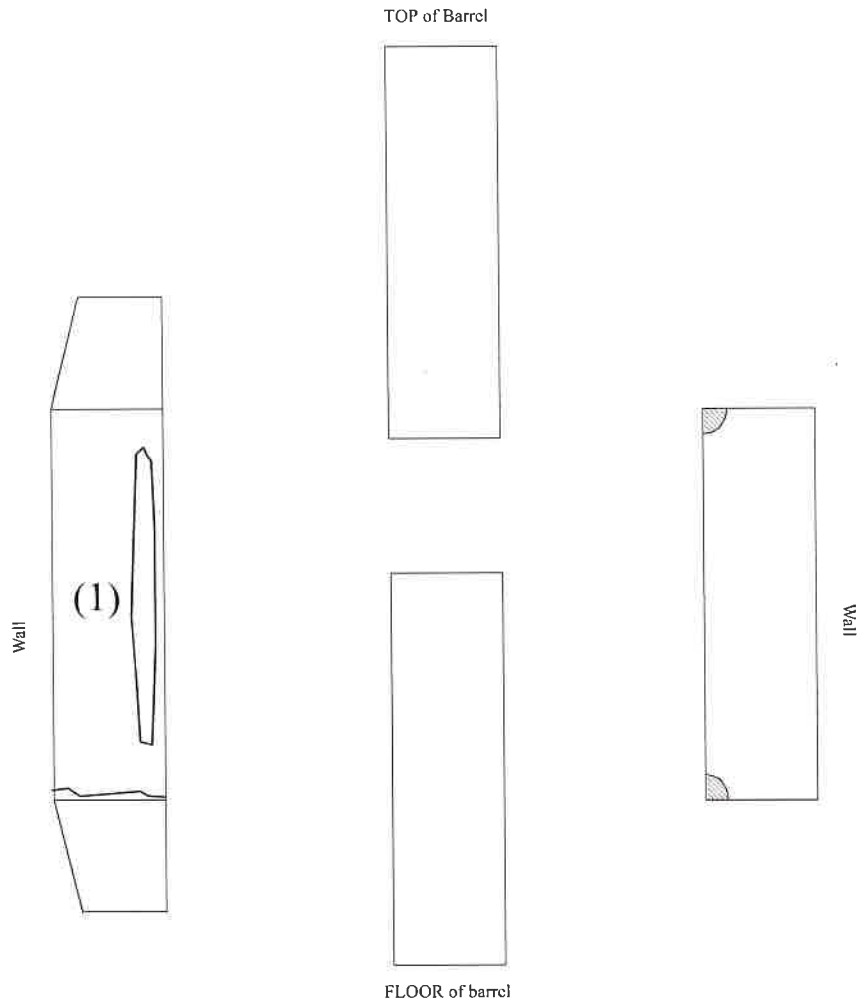
LOC. 05-1267-1.75		11-08-21 RC	BARREL 1 & 2
BARREL:	P	(1) SPALLING AND HONEYCOMBING UP TO 8" DEEP EXPOSING FILL BEHIND OUTSIDE WALLS	
		CRACKING WITH HEAVY SEPARATION OF BARRELS AND WINGWALLS	
		HEAVY SCALE OF MID-WALL AT OUTLET WATERLINE
